Final Report

NASA CR-132265

FERRITE LOGIC RELIABILITY STUDY

NATIONAL AERONAUTICS AND SPACE ADMINISTRATION
LANGLEY RESEARCH CENTER
HAMPTON, VIRGINIA 23365

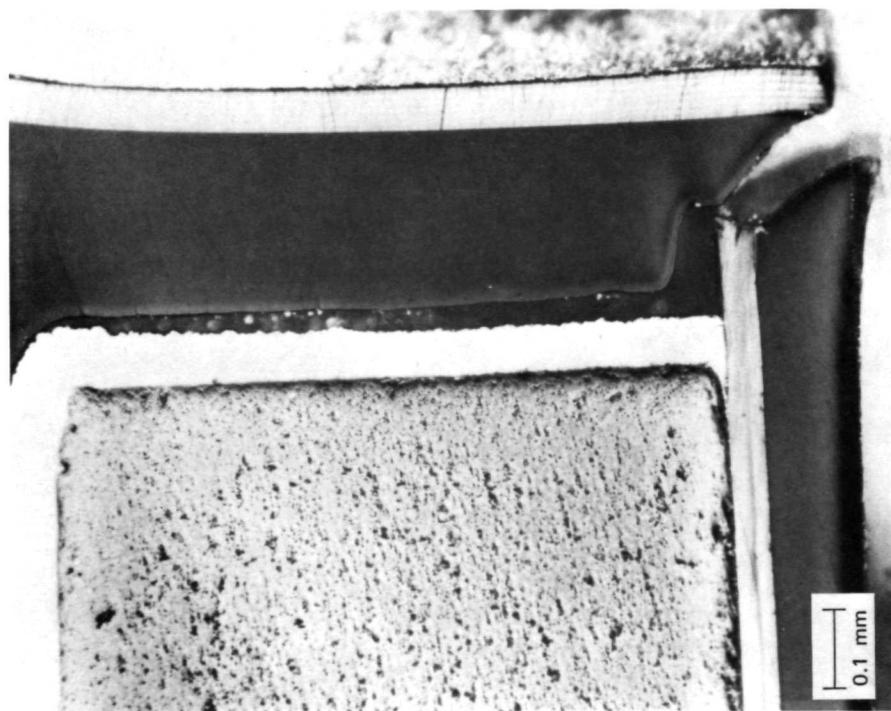
After additional grinding and polishing, the photograph shown in Figure 18A was taken. This was followed by more grinding and polishing and then the view shown in Figure 18B was photographed. The magnification of both photographs is 100, and the portions of the crack shown are nearer Location 68 than was the view in Figure 16. Note that the character of the crack as shown in Figure 18B is different than it was at the other grinding levels. In Figure 18B the Pyre-M.L. tube is no longer

(a) CROSS-SECTION NEAR LOCATION 68 AT 100X

(b) CROSS-SECTION AS IN FIGURE 18A AFTER
FURTHER GRINDING AT 100X

visible, the crack no longer skirts the edge of the Kapton, and the Kapton has ruptured part-way through its thickness. Arrow 1 points to the crack at the surface of the epoxy, and Arrow 2 points to the separation of the epoxy from the copper shield. The peculiar jagged rupture of the Kapton shown in the lower right corner of the photograph is of unknown origin.

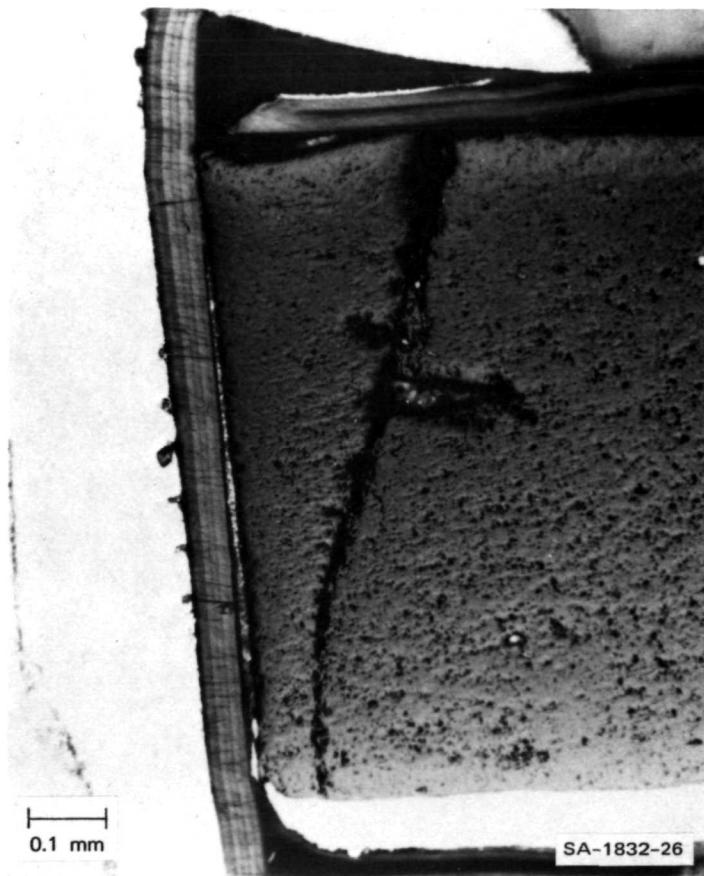
Another crack, shown in Figure 26 at 100 times magnification, is near a drive aperture, Location 65. Note that this crack has the same character as the previous one in that it proceeds completely through the thickness of the ferrite from one end to the other, and it is approximately orthogonal to the top and bottom surfaces of the ferrite.

FIGURE 26 CRACK NEAR DRIVE APERTURE AT 100X
